Boulder Survey

Acoustic Corer Sub-Seabed Cobble and

Gennaker Offshore Substation (OSS)

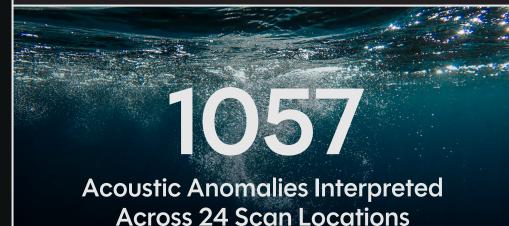
Figure 2 - Triple acoustic core results compared to another 3D acoustic system's results. The hashed red area is from the other 3D acoustic system and the dots are the AC results

Each scan location consisted of a triple acoustic core. Three 12 m diameter acoustic cores were collected and merged in a triangular pattern to form a single interpretable acoustic volume. Each acoustic core was laterally and vertically aligned to ensure a continuous response with no offsets between each acoustic core.
